DANIEL K INOUE INTL (HNL) ARRIVAL ALERT

Landing Northeast RWY 4L and RWY 4R

HONOLULU (DANIEL K INOUEY INTL) AIRPORT HNL RUNWAY INCURSION AND WRONG SURFACE LANDING RISKS

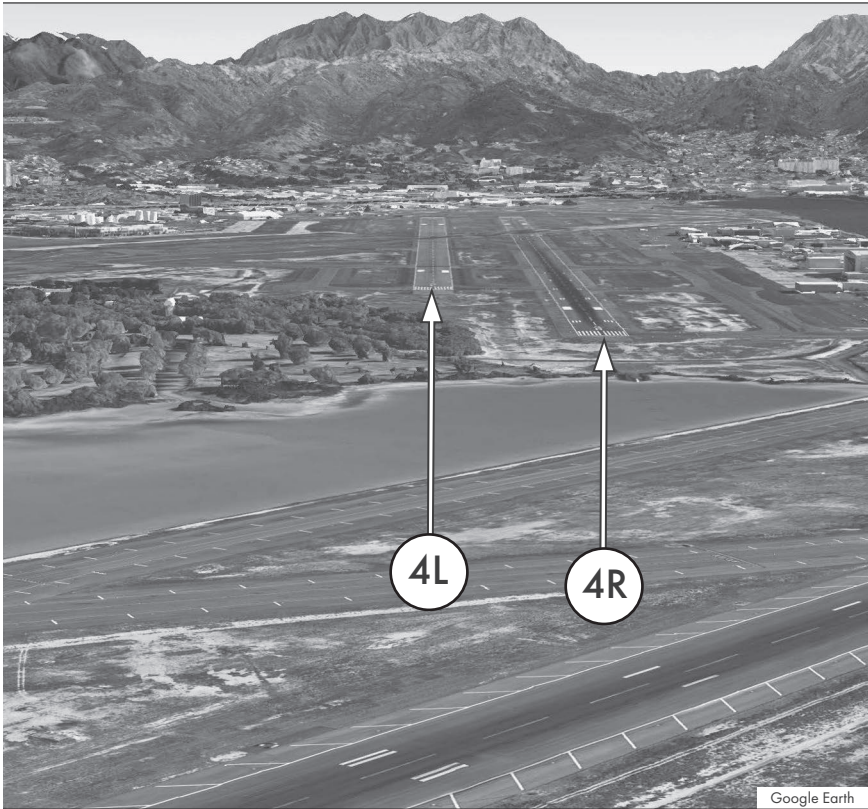
Pilot sometimes confuse RWY 4L and RWY 4R.

Wrong Surface Landing Risk: Rwy 04R/Rwy 04L thresholds. Pilot expectation bias or runway confusion cause a potential for wrong runway landings. Pilots are reminded to acknowledge landing runway assignment and visually confirm lined up for the correct runway.
