DANIEL K INOUYE INTL (HNL) ARRIVAL ALERT

Landing Northeast
RWY 4L and RWY 4R

HONOLULU (DANIEL K INOUYE INTL) AIRPORT
HNL RUNWAY INCURSION AND WRONG SURFACE LANDING RISKS

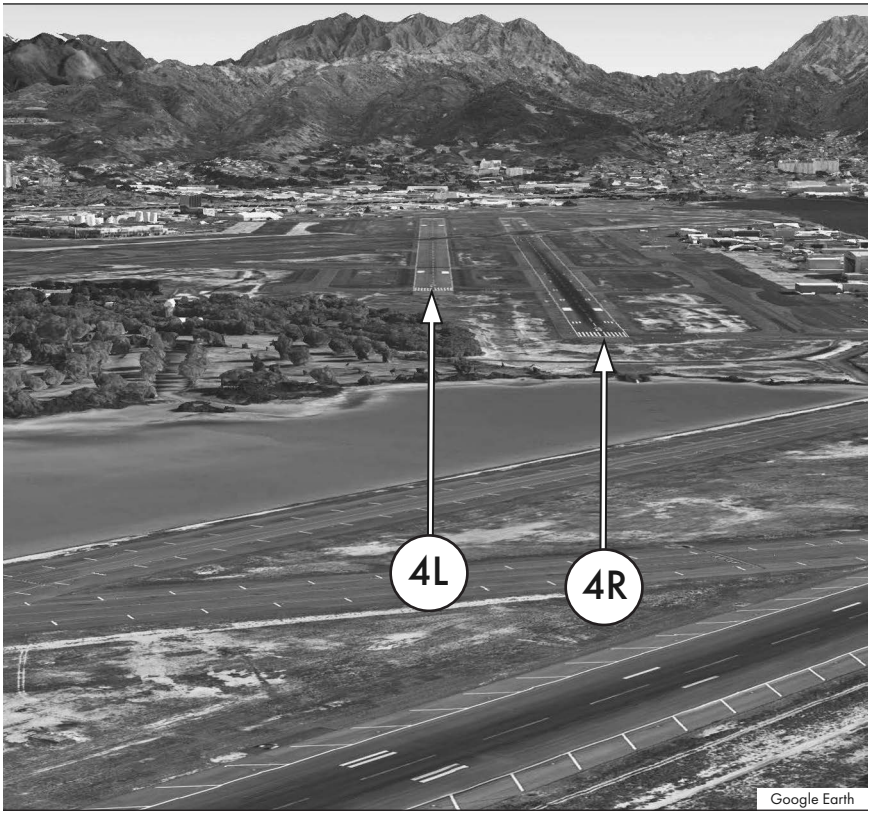
Pilot sometimes confuse RWY 4L and RWY 4R.
