MOLOKAI (MKK)(PHMK) 6 NW UTC-10 N21°09.17' W157°05.78'
454 B TPA—See Remarks Class I, ARFF Index A NOTAM FILE MKK
RWY 05-23: H4494X100 (ASPH-GRVD) S-30, D-48 PCN 12 F/B/Y/T MIRL

HAWAIIAN ISLANDS

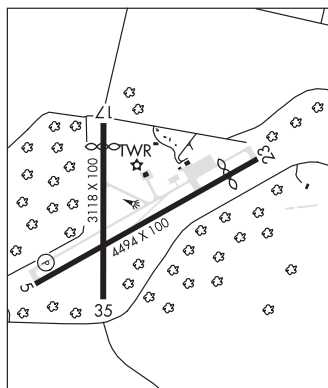
0.4% up NE

RWY 05: REIL. PAPI(P4L)—GA 4.0° TCH 49'

RWY 23: H3118X100 (ASPH) S-13 PCN 11 F/B/Y/T MIRL

RWY 17: Thld dsplcd 426'. Fence.

RWY 35: Fence.
